Manhole Inspection Summary

Manhole # S33U__015MH

Insp Date: **2/6/08 3:41 PM**

Location Address: **race st**

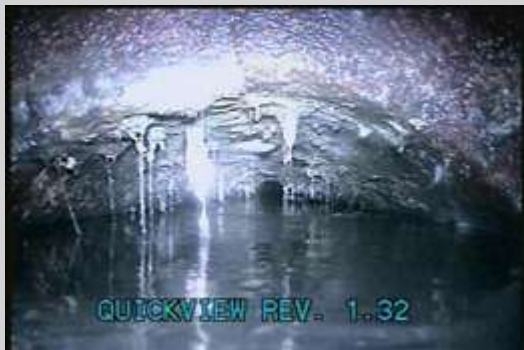
12 O'Clock Outflow

24 in. Circular Gravity Sewer
Pipe Out @ 12 O'Clock

Invert Depth: **24.50** (ft.) Flow Characteristics: **Slow**

Infiltration: **None** Pipe Seal Cond: **Unknown**

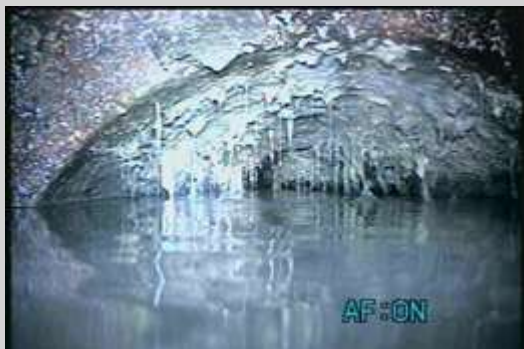
6 O'Clock Inflow

24 in. Circular Gravity Sewer
Pipe In @ 6 O'Clock

Invert Depth: **23.90** (ft.) Flow Characteristics: **Slow**

Infiltration: **None** Pipe Seal Cond: **Unknown**
